Technical Report

TR-06-44

**Natural analogues for expansion
due to the anaerobic corrosion
of ferrous materials**

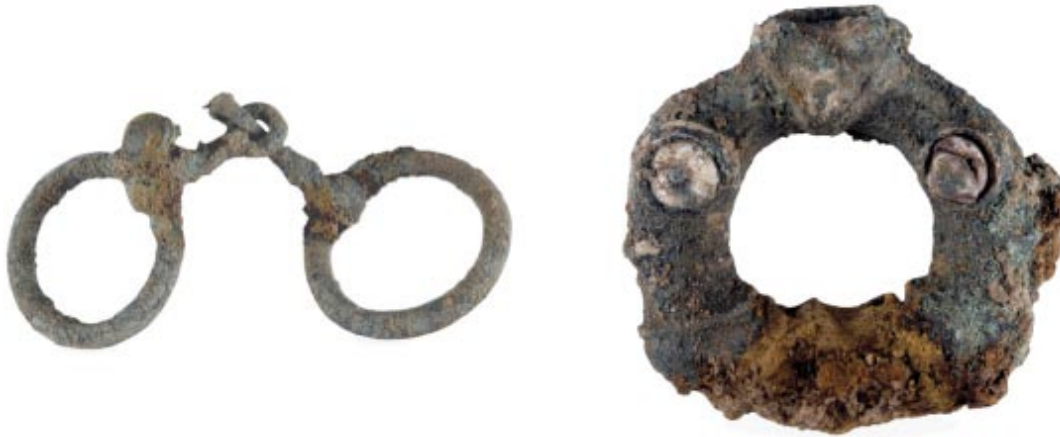
Figure 3-1. Horse bit and rein ring from Wetwang chariot burial site (courtesy of British Museum).

The horse bits were made of iron and bronze. The central part was formed of cast bronze, and bronze sheet had been hammered over iron rings on either side of the central part. The bits were delicately made; even the part in the horses' mouths was decorated. It is noticeable that distortion of the bronze sheet on the rings had not occurred, even though water is likely to have penetrated into the crevice between the iron and the bronze, and caused corrosion of the iron.

British Iron Age chariots usually had five rein rings, or 'terrets', fixed along the top of the wooden yoke that spanned the horses. The rein rings consisted of a bronze section which was joined to an iron rod in the central region. The bronze section was decorated with pieces of embedded red coral or glass. It is clear that severe expansion damage had not been inflicted on the bronze components of the rein ring (Figure 3-1).

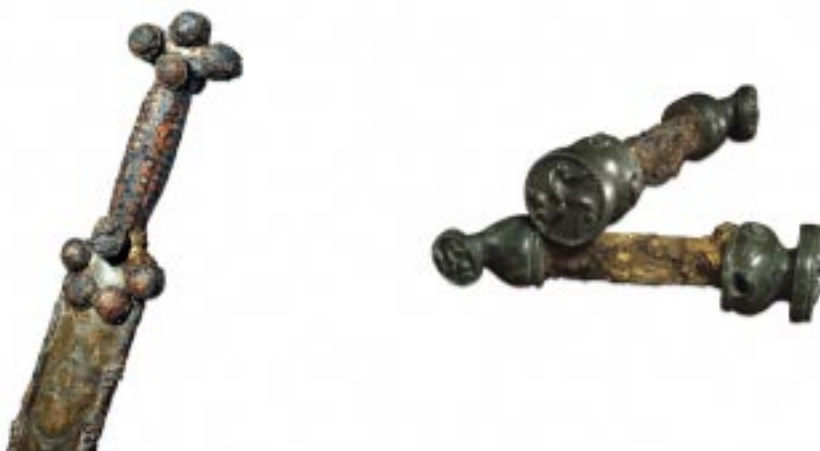
Figure 3-2. Handle of sword and Linchpins from Kirkburn chariot burial site (courtesy of British Museum).

Two other artefacts of relevance from the same period of the Iron Age (200–300 BC) and area (East Yorkshire, U.K.) are a sword and a pair of linchpins from another chariot burial at Kirkburn. British Museum archaeologists excavated the sword in 1987. The handle of the sword is unusually elaborate, being made of thirty-seven different pieces of iron, bronze and horn (Figure 3-2).

The decorated linchpins supported the wheels of a cart or chariot on their axles. The main parts are made of iron, while both ends were decorated with a bronze cap, cast onto the iron bar. There are no indications of expansive damage to the bronze caps at the end of the iron rods.

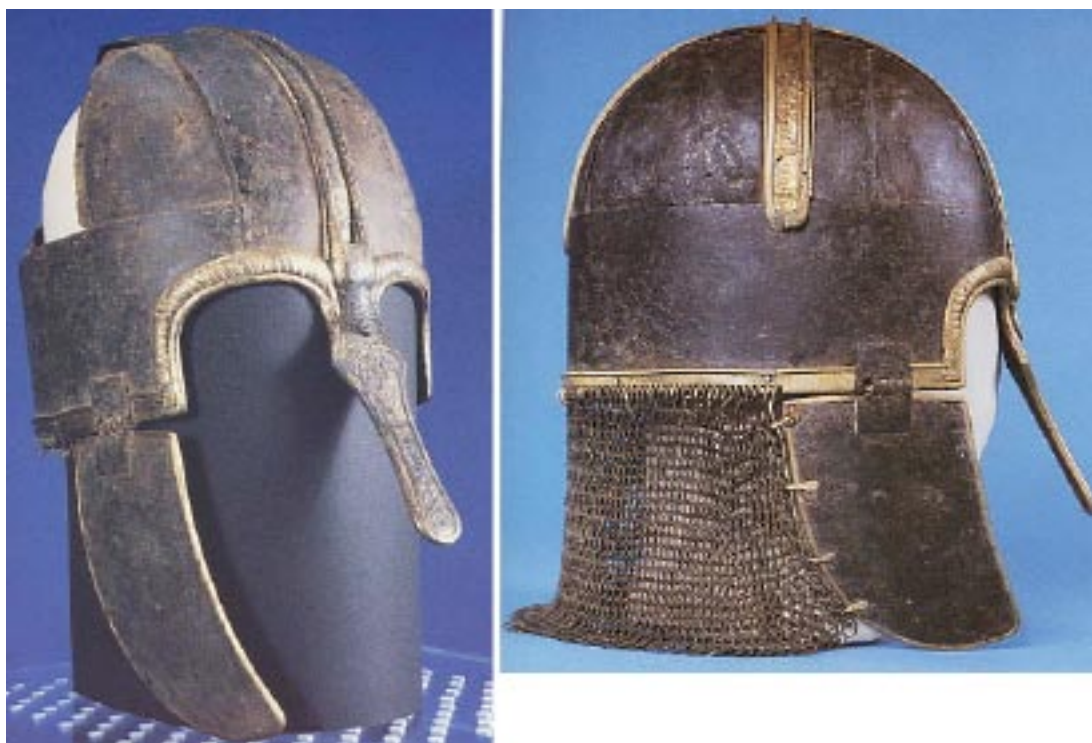
Figure 3-3. The Coppergate Helmet after conservation, (a) after conservation, and (b) after conservation and reconstruction (courtesy of Council for British Archaeology).

The corrosion that occurred while the helmet was in the ground varied from a light surface coverage of a black corrosion layer to severe patches of attack on the right cheek-piece and the rear left of the brow band. The dense black deposit was identified as siderite (FeCO_3) and this had partially replaced the iron [72]. The formation of siderite probably resulted from reaction with carbonate in the groundwater derived from demolished Roman plaster and mortar buildings that were previously on the site.

The back left browband of the helmet had been virtually removed and it was unclear whether this attack had been before or during deposition. This was also the case with the left cheek-piece; half of it had shattered because it mainly consisted of brittle replacement corrosion. The parts of the helmet covered by the brass fittings or where the plates were riveted and overlapped were obviously free of crust. The inside of the helmet was dark and smooth and corrosion in the cap was clearly visible.

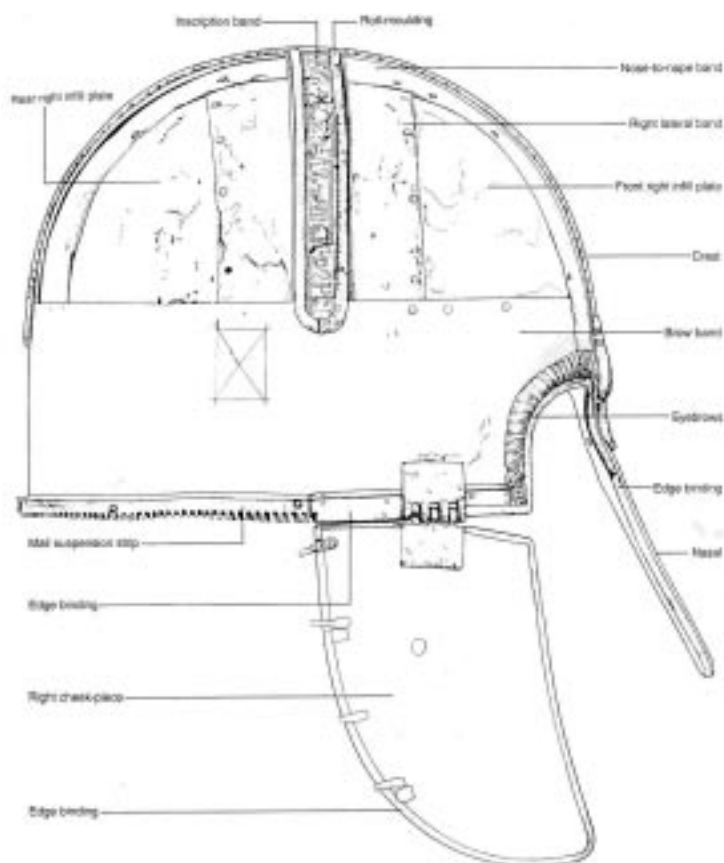
Figure 3-4. Construction of Coppergate Helmet.

Archaeologically, the Coppergate Helmet is a fascinating object, which has been rigorously studied /71/. For the purposes of the present discussion, the most interesting features of the helmet are those regions where constrained geometries were present between copper alloy and iron, and between the iron components, for example under the rivet heads, between plates of iron and in the chain mail hinge. In these regions there are no indications of gross distortion due to the formation of a voluminous corrosion products. The corrosion product was mostly siderite (FeCO_3). Based on considerations of theoretical density, formation of siderite would cause an expansion of 4.2 times compared to the base metal /61/.

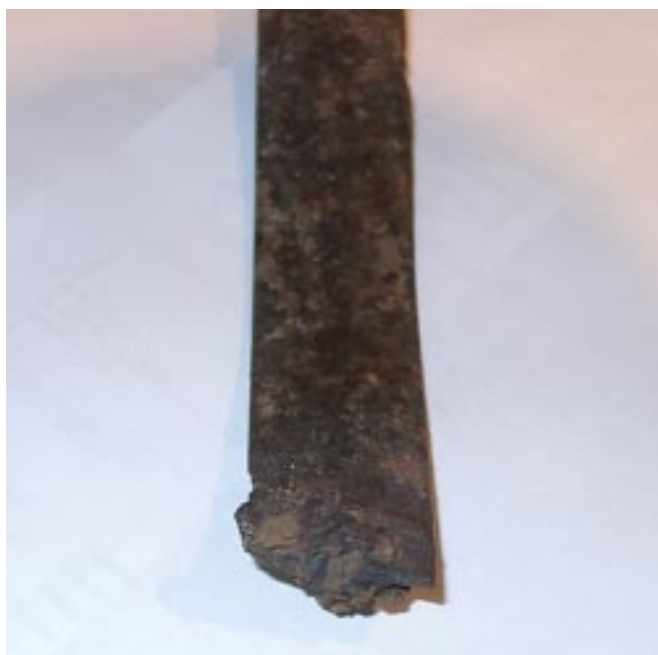
Figure 3-5. A broken part of the sword beater (courtesy of Council for British Archaeology).

This object (Figure 3-5), used in weaving, measures approximately $\frac{3}{4}$ metre long with a wooden handle. It was found in the same pit as the helmet and therefore it was assumed that it was exposed to the same environment for the same amount of time. The sword beater had broken in two places, so that the iron core was visible and the exfoliating replacement corrosion of the iron was clear.
