Kronan cannon (Sweden)

Description: The Kronan cannon study is an archaeological analogue that investigated the effects of corrosion on the copper barrel of a 17th Century bronze canon (Figure 1).

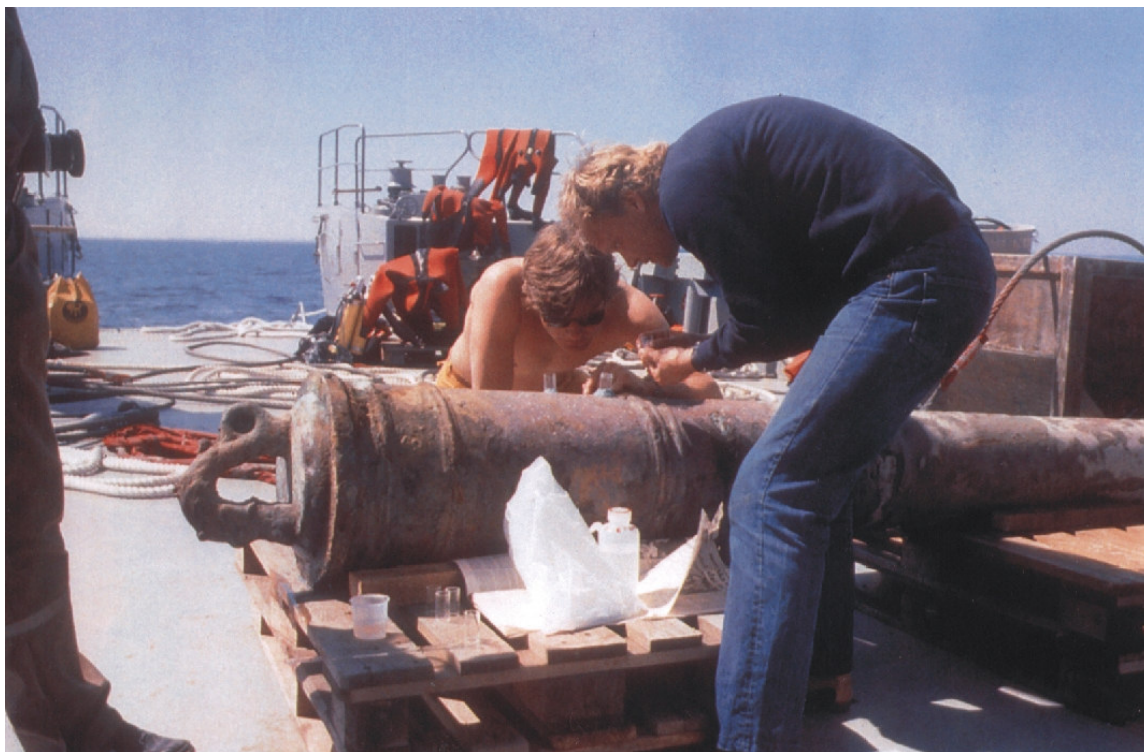
Figure 1 Examination of the Kronan cannon soon after it was recovered from the Kronan shipwreck. Photograph courtesy of the Kalmar County Museum/The Kronan Project.

The analogue study focussed on a particular bronze cannon which had remained partly buried in a vertical position, muzzle down in clay sediments since the ship sank (Neretnieks, 1986; Hallberg et al., 1987). The cannon studied has a very high copper content (96.3 wt%) and is analogous to the copper outer shells of the canisters planned to be used for spent fuel in the Swedish and Finnish repository designs.

Analysis of the cannon surface showed that corrosion had progressed at a mean rate of 0.15 $\mu\text{m}/\text{y}$ since the Kronan sank and that this process was constant over the whole cannon surface, except where some copper oxide (CuO) inclusions had corroded more quickly. Identified corrosion products include Cu_2O and Fe_3O_4 which confirm a generally oxidising environment. No change in oxidation product with change in redox potential due to limited seawater penetration at depth was observed. Hallberg et al. (1987) concluded that oxygen may not be the principal oxidising agent because the corrosion products were the same all over the cannon surface.
